Report to Scrutiny Panel

Name of Scrutiny Panel	Economy and Environment	
Meeting Date	13 April 2011	
Subject	Brookfoot Hill	
Wards Affected	Brighouse	
Report of	Director, Economy and Environment	
Type of Item (please tick✓)	Review existing policy	
	Development of new policy	
	Performance management (inc. financial)	
	Briefing (inc. potential areas for scrutiny)	
	Statutory consultation	
	Council request	
	Cabinet request	
	Member request for scrutiny (CCFA)	✓

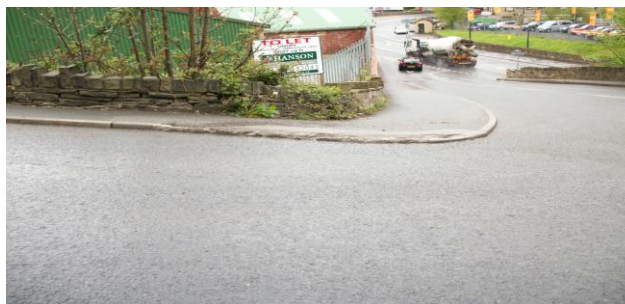
Photo 100_0131)

2009 results show the potentially problematical area of Brookfoot Lane as being at the bottom of the hill, for uphill bound traffic (see *photo100_0131*), with another area of possible concern being the Hazel Lea to Marshalls section.

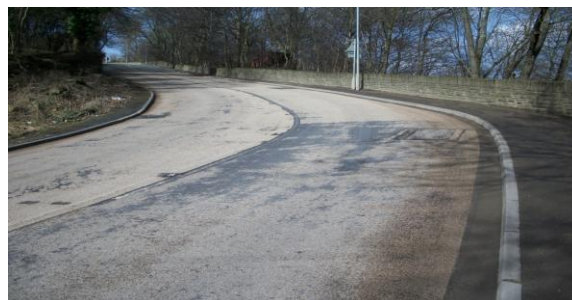
Photo 100_1124

There is also some deterioration noted on the high friction surfacing towards the top of the hill near to the recently built wall (see *photo 100_1124*) although it must be noted that this section of road is not deemed as poor (red) on the Skid resistance or Scanner survey results so no maintenance is yet required or planned.

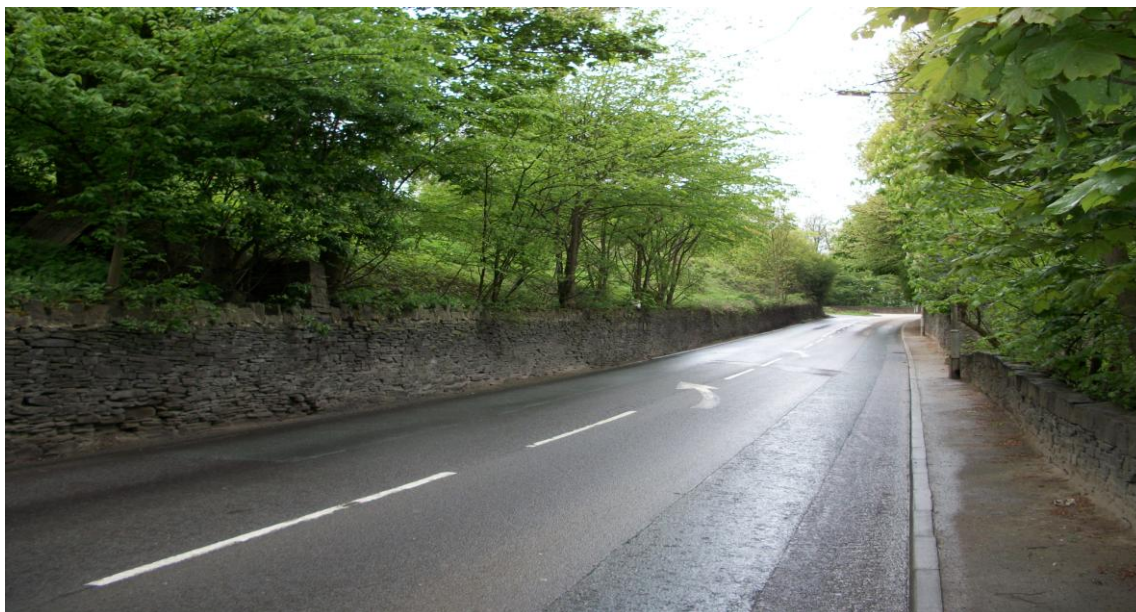
Photo 100_0133

There is evidence of previous carriageway patching but the condition of the road surface is generally satisfactory – (*photos 100_0133 & 100_0140*).

These areas of road (highlighted as red on Appendix 3) have been inspected and only minor routine maintenance is required in the form of carriageway patching. This will be carried out in 2011/12 as part of a planned routine maintenance programme.
