Flood Investigation Report

Section 19, Flood & Water Management Act (2010)

Upper Calder Valley – 29th July 2013 Flooding Incident

Document Title: Upper Calder Valley – 29th July 2013 Flood Investigation
Report

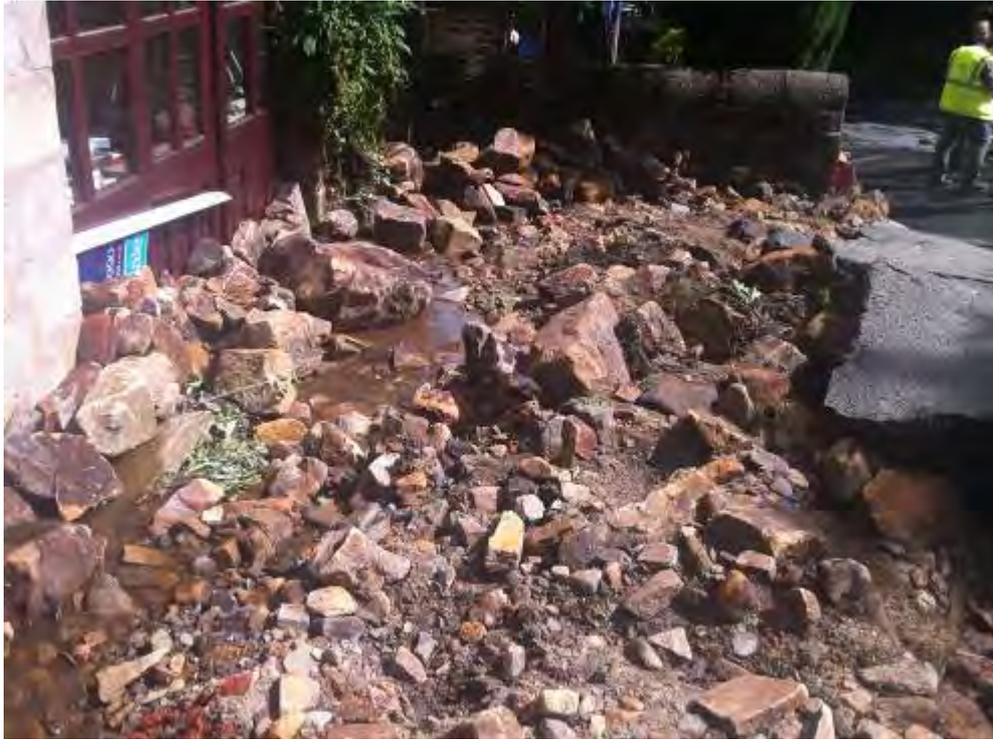
Large boulder material blocked the culvert under Kershaw Road resulted in the culvert surcharging immediately behind 1 and 3 Melbourne Road. This resulted in a collapse of the main culvert in Kershaw Road adjacent to 1 Calf Hey Terrace. Excess surface water and debris from the collapsed structures overflowed onto Clough Road and adjoining streets, causing significant damage to the highway and nearby properties.

Figure 2 – Debris from the collapsed culverts onto adjacent property

Immediately after the rainfall event the Council committed to tidying up the site in an attempt to get water back below ground and repair the collapse culvert in Kershaw Road. This required a gas main diversion. All the damaged surfacing was removed and the top taken off the masonry culvert which is largely in private land. A temporary running surface was created in Kershaw/Clough Roads. The remaining piece of culvert under Kershaw Road was cleared of debris without removing the top to preserve access for residents and contractors. The

remaining sections of the culvert are thought to be in reasonable condition under Kershaw Road. A temporary steel plate was laid over it to protect it from traffic loadings following removal of surfacing. This has since been removed and resurfacing work has been completed.

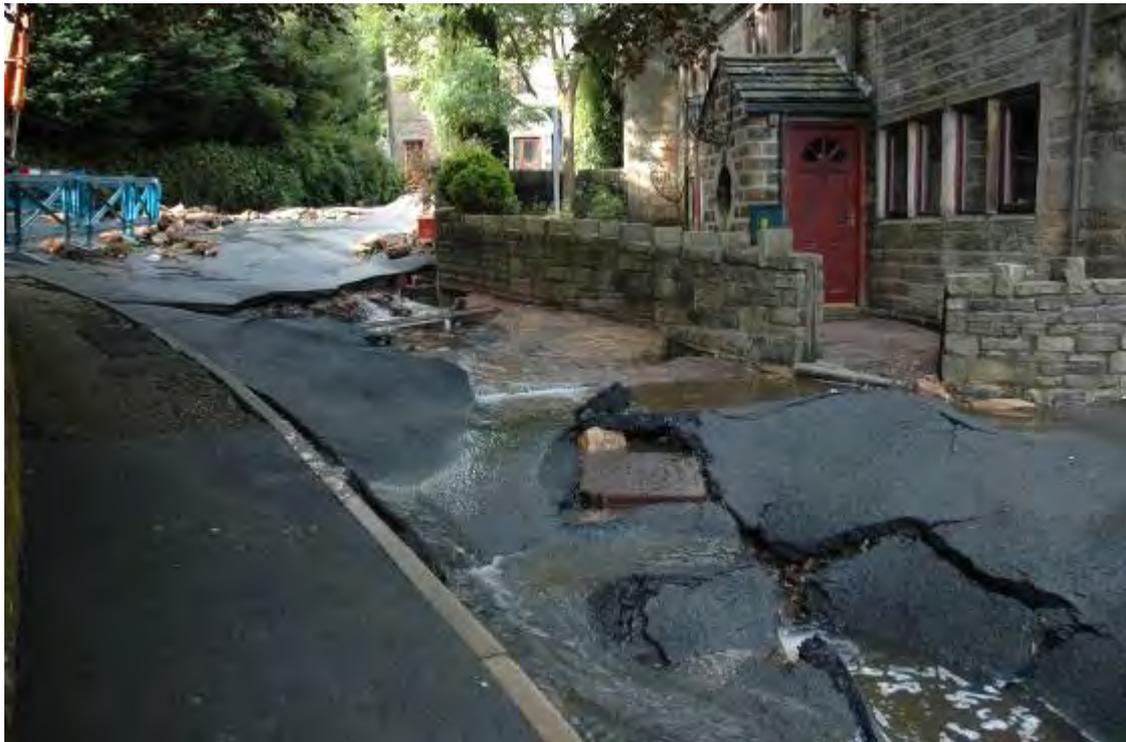
Figure 3 – Kershaw and Clough Road, road surface severely damaged as a result of the excess surface water on Clough Road.

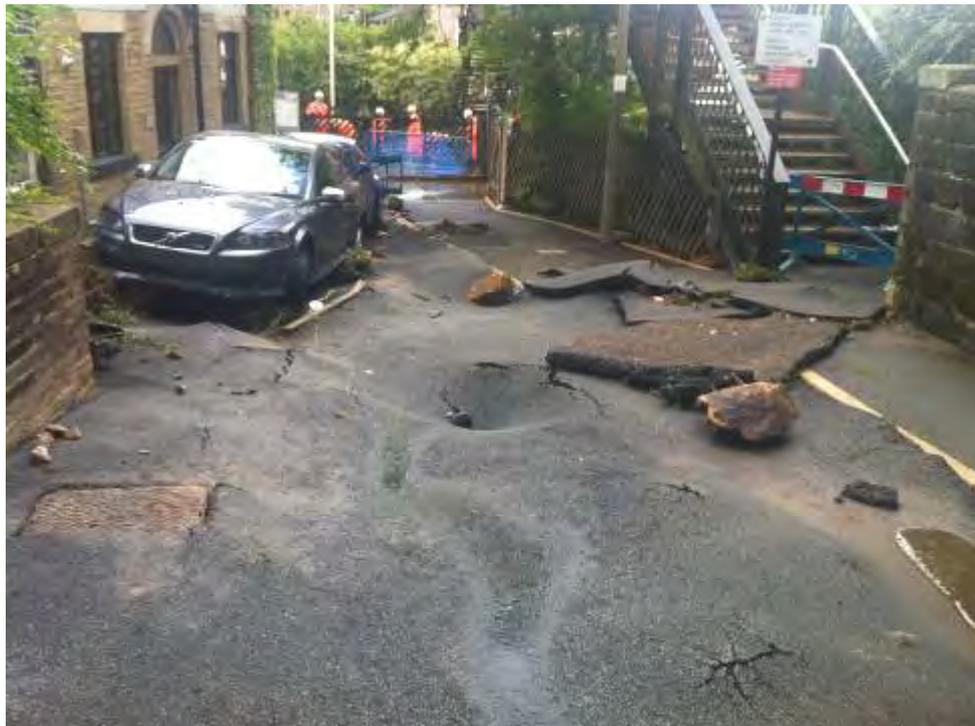
At the lower end of Clough Road the excess surface water could not flow back into the watercourse and therefore spilled onto the railway track, flooding the rail

track at Walsden Station. Similar to the summer 2012 events the excess surface water spilled onto Rochdale Road and flooded the highway and adjacent properties.

Figure 4 – View looking down slope on Clough Road towards the railway line.

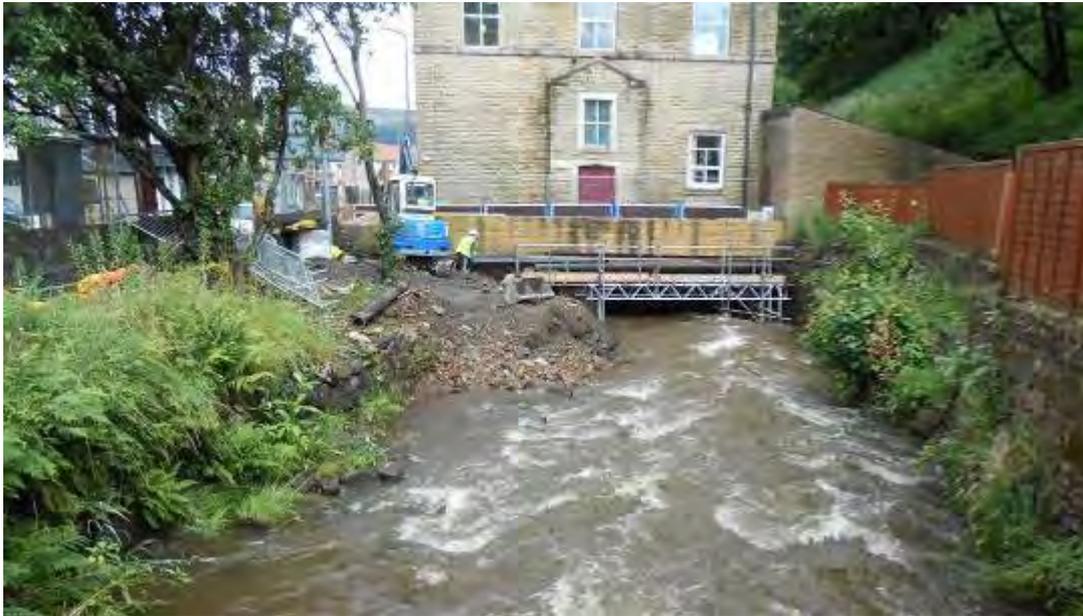
After the peak rainfall, Walsden Water's river level in the Shade area (with significant contribution from Midgelden Brook) rose significantly over a short duration. Flood defences are currently being constructed just north of the junction between Bacup Road and Rochdale Road on the Walsden Water, as part of the third phase of the Todmorden Flood Alleviation Scheme. On the 29th July the flood defence wall above and adjacent to the culvert immediately next to Shade Chapel was being constructed. Temporary works partially constricted the river channel while the work was being undertaken (see figure 5). The Environment Agency had also removed a section of riverside wall to allow access to the river for plant and materials. Temporary defences were in place to maintain the standard of flood protection (see figure 6).

Figure 5 – View looking downstream at the temporary construction works on the culvert on the Walsden Water.

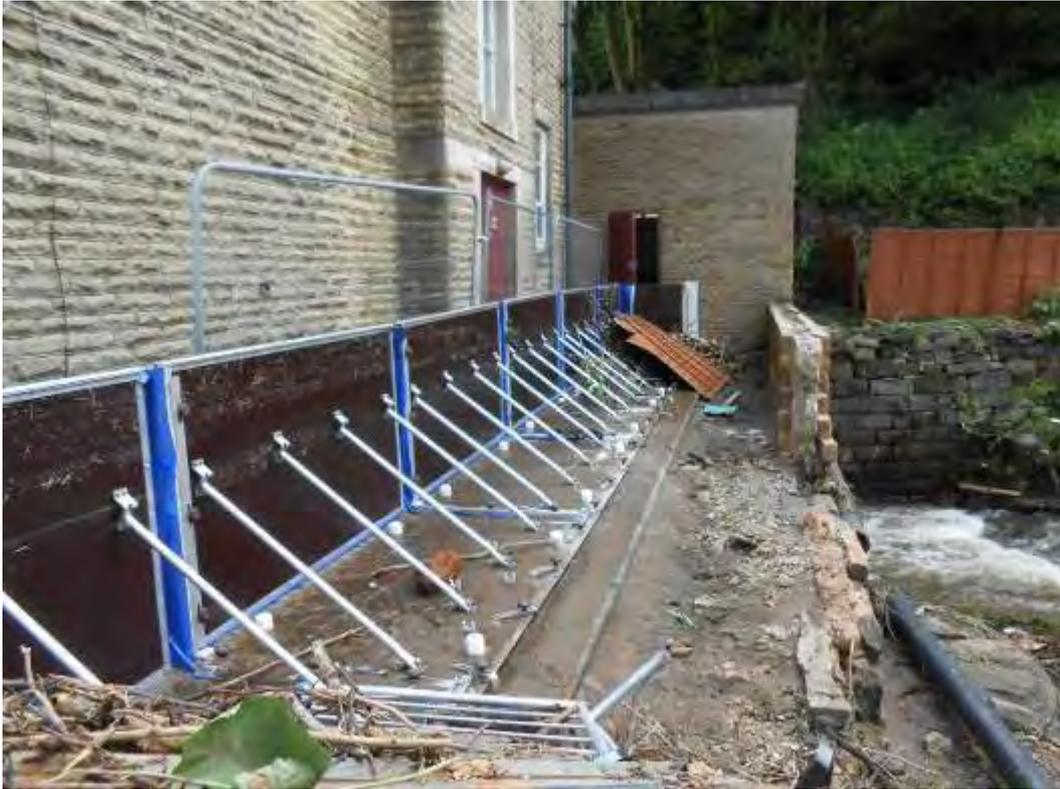
Figure 6 – Damaged caused by flood waters on the new unfinished flood wall being constructed. During the flood event a section of the temporary works collapsed, reducing the capacity of the channel. The constriction at the culvert caused an increase in the level of flood waters upstream of the culvert. Approximately 50 metres upstream is a small, privately owned, masonry vehicle access bridge which suffered structural damage resulting in the collapse of the bridge parapet and masonry facing.

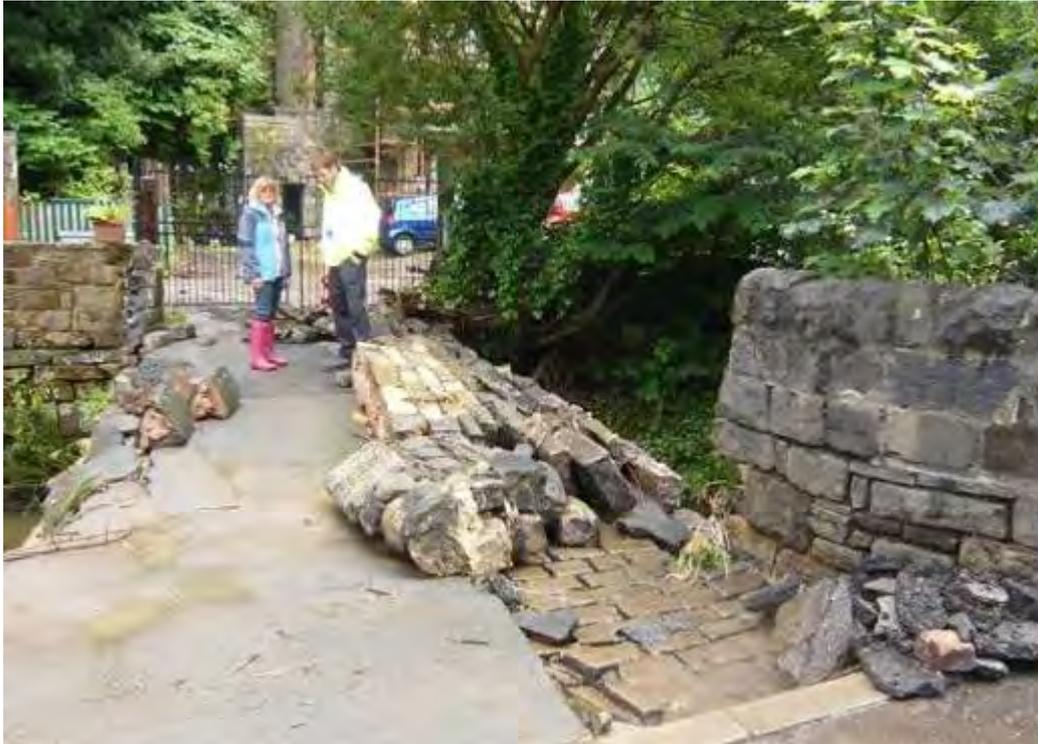
Figure 7 – Damage to the bridge and parapet walls after the flood event on an access bridge on the Walsden Water.

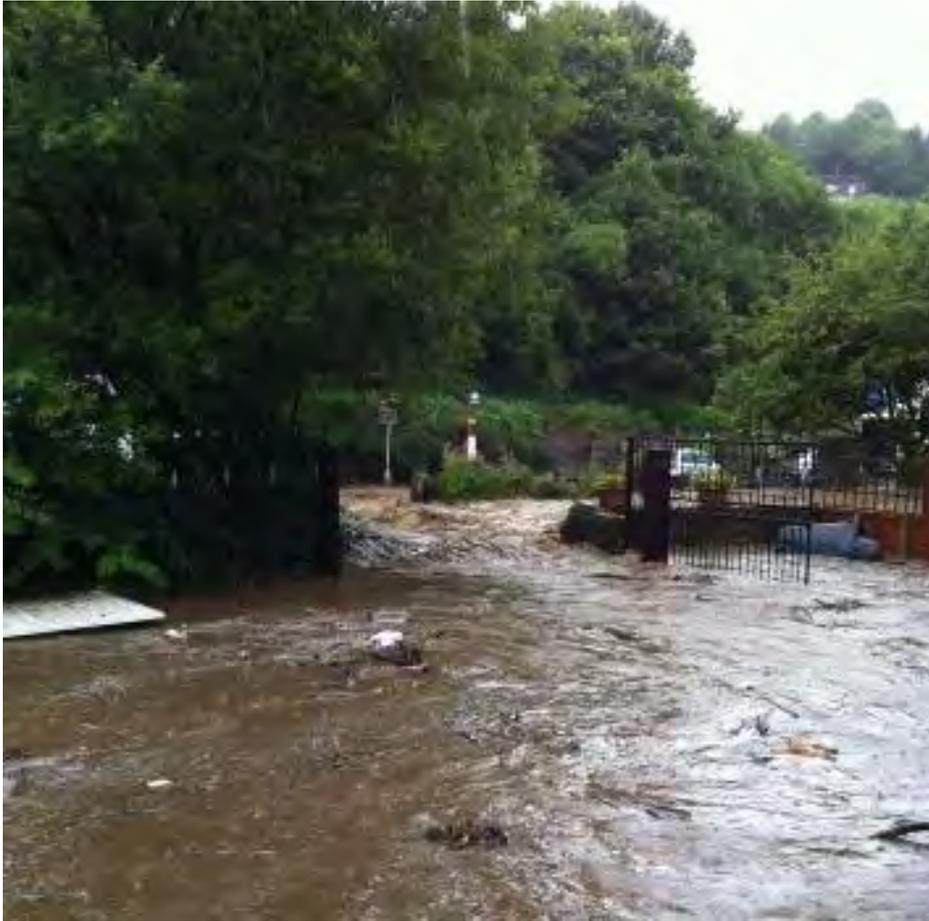
The collapse of the bridge parapet walls allowed the flood waters to spill onto Rochdale Road (as shown in Figure 8). The flood waters combined with the surface water flooding, flowed towards the resident and commercial areas of Shade and Salford. This exacerbated the flooding which had already taken place.

Figure 8 – Flood waters spilling onto Rochdale Road during the flood event.

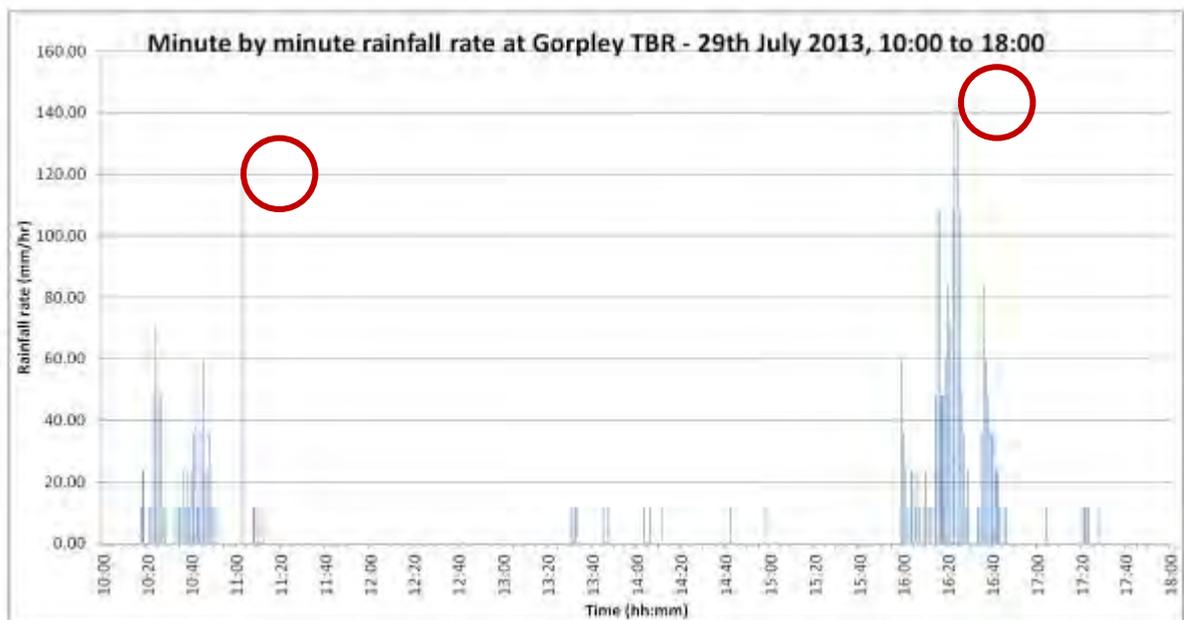
Significant rainfall fell on Monday 29th July within the Walsden Water branch catchment of the River Calder. Table 1 below illustrates the rainfall intensities record at the rain gauge at Gorpley reservoir, located approximately 500m south of Bacup Road (A681) on the moorland area.

Table 1 – Rainfall intensities for Monday 29th July at Gorpley Reservoir.

The table shows that there were two distinct high intensity rainfall events. The largest event occurred between 16:00 and 16:40 GMT (5:00pm to 5:40pm BST), falling on an already saturated area. The most intense period of rain in this event equates to 140mm per hour and lasted approximately 2 minutes. The second largest rainfall event occurred at approximately 11:10 equating to 120mm over two minutes. Further bursts of intense rainfall throughout the day equated to approximately 60mm per hour. The data shows that the majority of the rainfall (calculated as being a 1 in 20 year return event) fell in just two or three minutes.

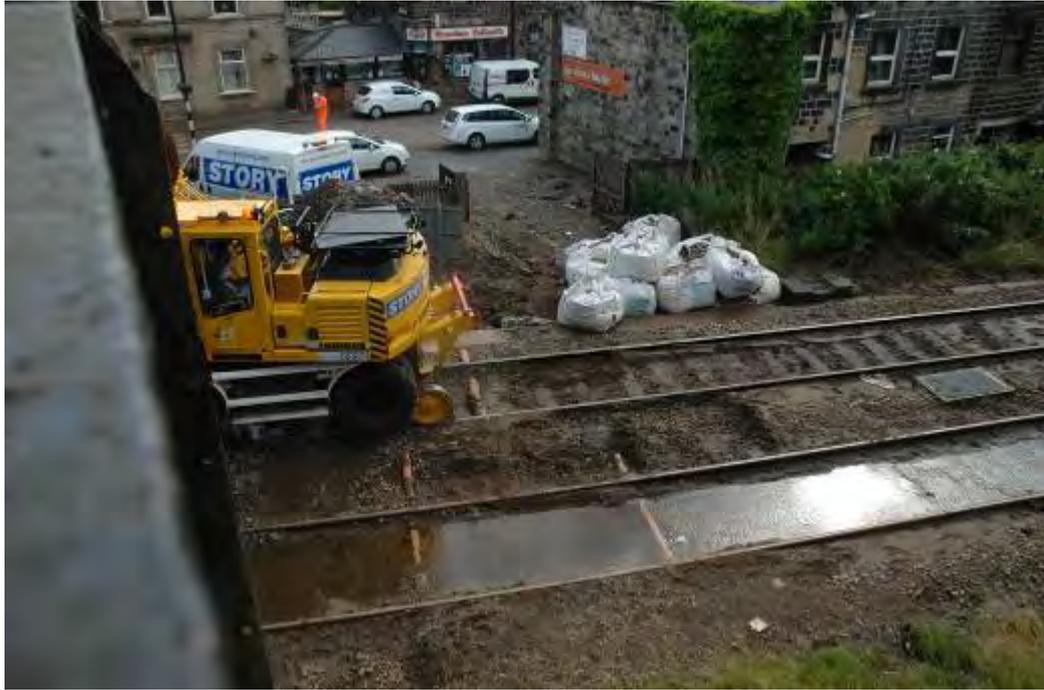
The stretch of rail track at Walsden Station has been badly affected by the flooding from the culvert collapse along Kershaw Road. Network Rail in conjunction with the EA, CMBC and consultants are currently undertaking drainage and flooding assessments of the area to examine the flooding mechanism (s) and to identify solutions.

Figure 9 – Network Rail repair teams removing large volumes of debris and reinforcing rail track immediately after the flood event.
