Briefing Note

Mytholmroyd channel maintenance

What types of channel maintenance have we considered on the River Calder through Mytholmroyd?

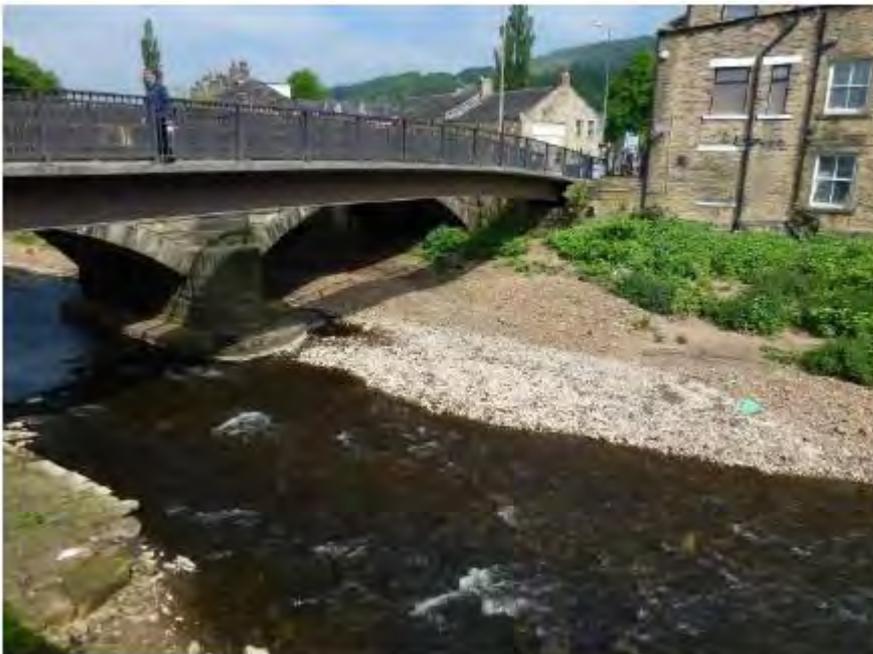
Plate 1. New Road Bridge looking upstream. Shoal has built up under the left arch of the bridge.

There are shoals of gravel and soil that have built up in parts of the river channel in Mytholmroyd. An example of this is around New Road Bridge (see plate 1 below). The shoal varies in size and extent over time as it is subject to both erosion and deposition due to the varying effects of river. At present, the shoal has been much reduced in size by the recent high flows. Many stretches of the watercourse are free from shoals. An example of this is opposite Royal Oak Apartments (see plate 2).

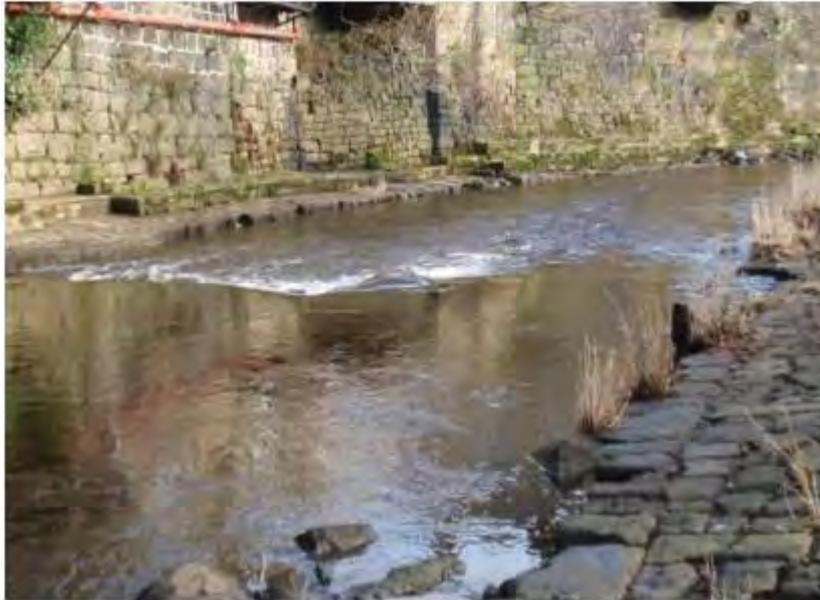
Plate 2. Royal Oak Apartments looking downstream. No shoal has been deposited on either bank of the river.

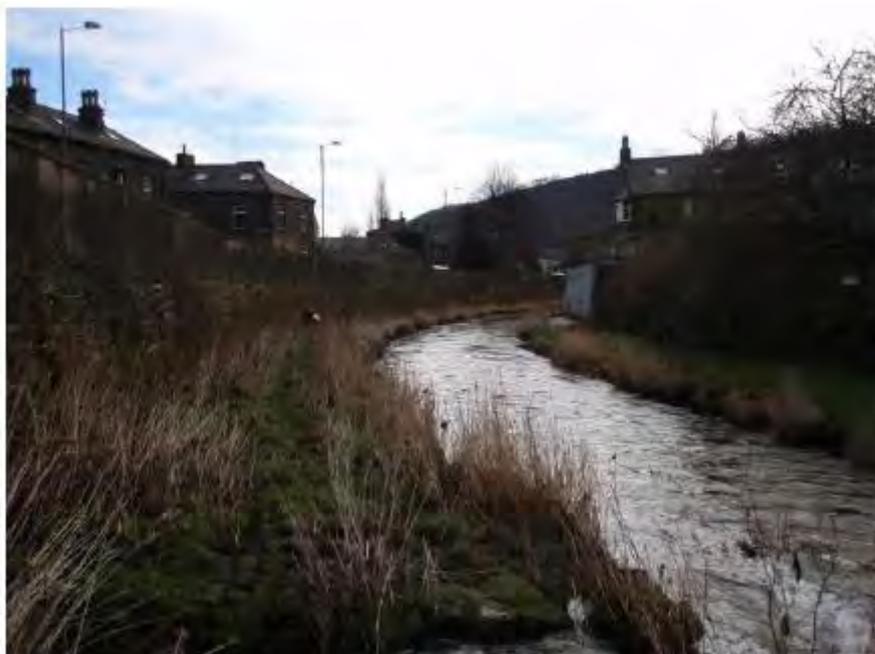
Plate 3 Looking downstream towards Caldene Br. Stone pitching and small amounts of winter vegetation

Knotweed, dying back in the winter but rapidly growing within the channel in the summer months. Plate 3 and 4 show changes in seasonal vegetation.

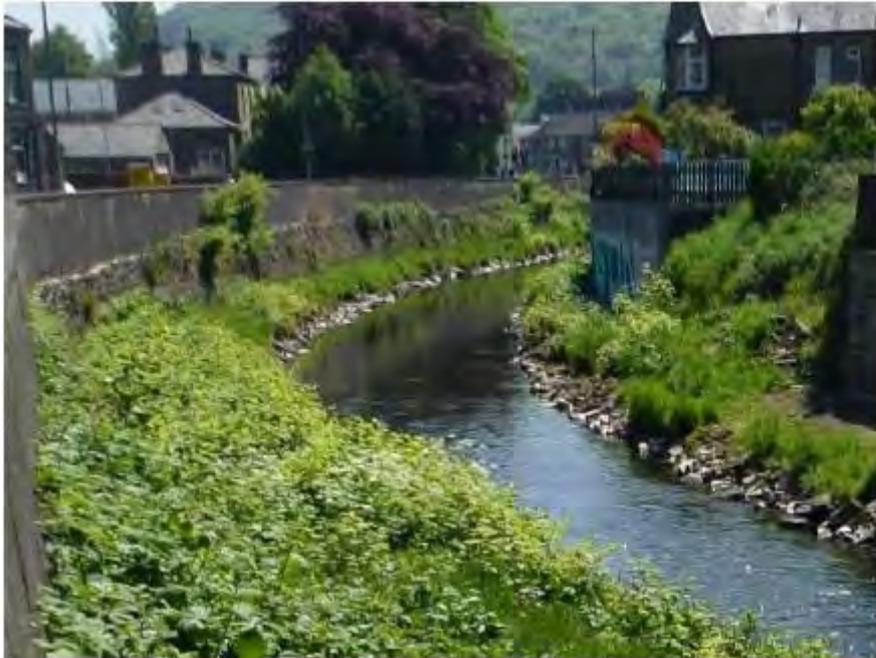
Plate 4. Looking downstream towards Caldene Br. Stone Pitching no longer visible through Summer Vegetation

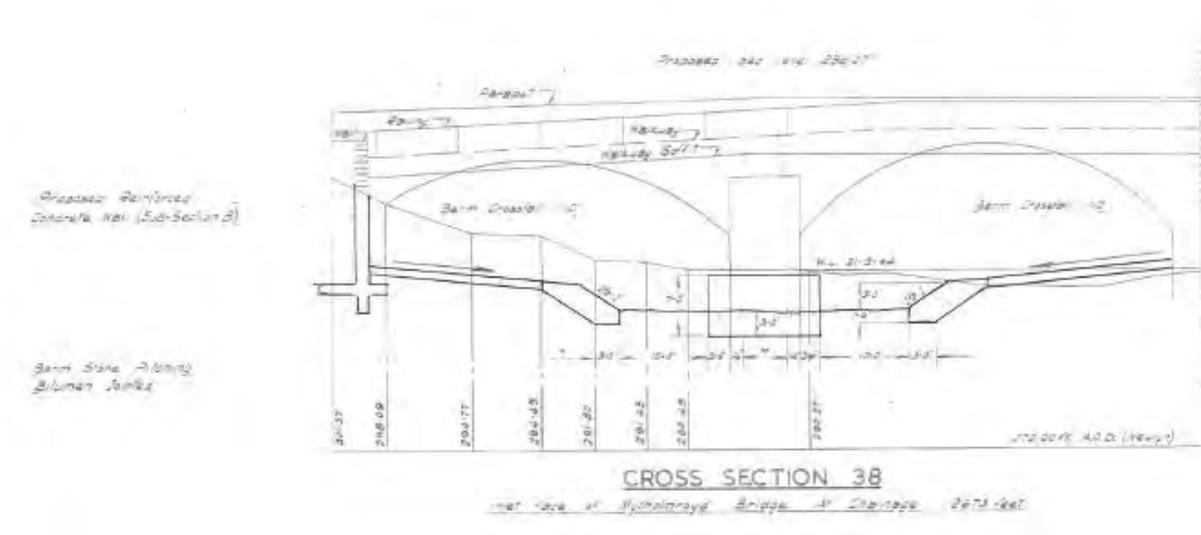
In the 1960s, our predecessors improved the channel capacity through Mytholmroyd. They widened and lowered the river. We have design drawings of the scheme showing the cross section of the river. Below is an example of the cross section at New Rd Bridge. This drawing indicates that the depth of the central channel is approx. 3ft.

Fig 1. Cross Section of the River Calder at New Rd Bridge from 1960's scheme

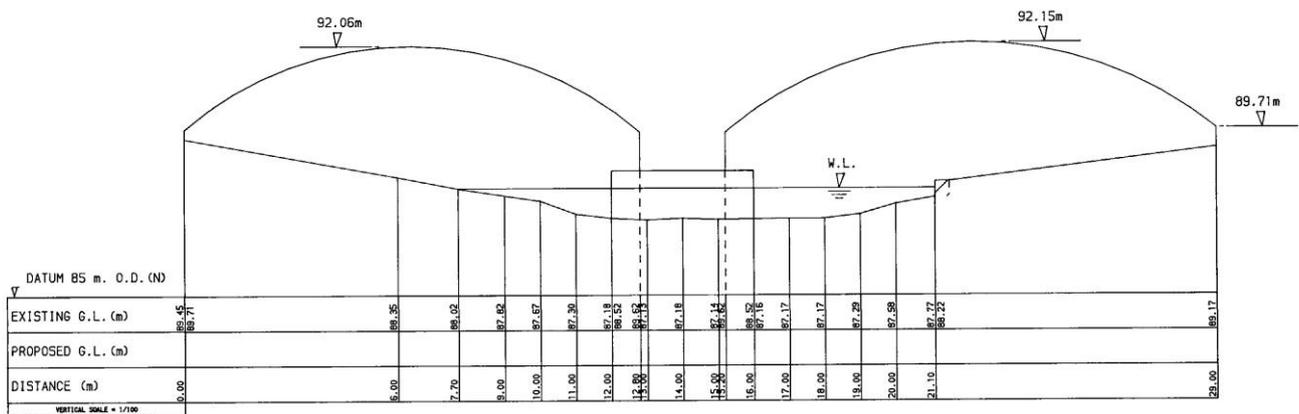
C.S. 12A Upstream Face of Mytholmroyd Bridge

We also have cross sections of the river from 1993 and 2009. These show that the depth of the central channel at the bridge has not changed and there is still a depth of 3ft from bed to the top of the central channel.

Fig 2. Cross Section on the River Calder at New Rd Bridge from 1993

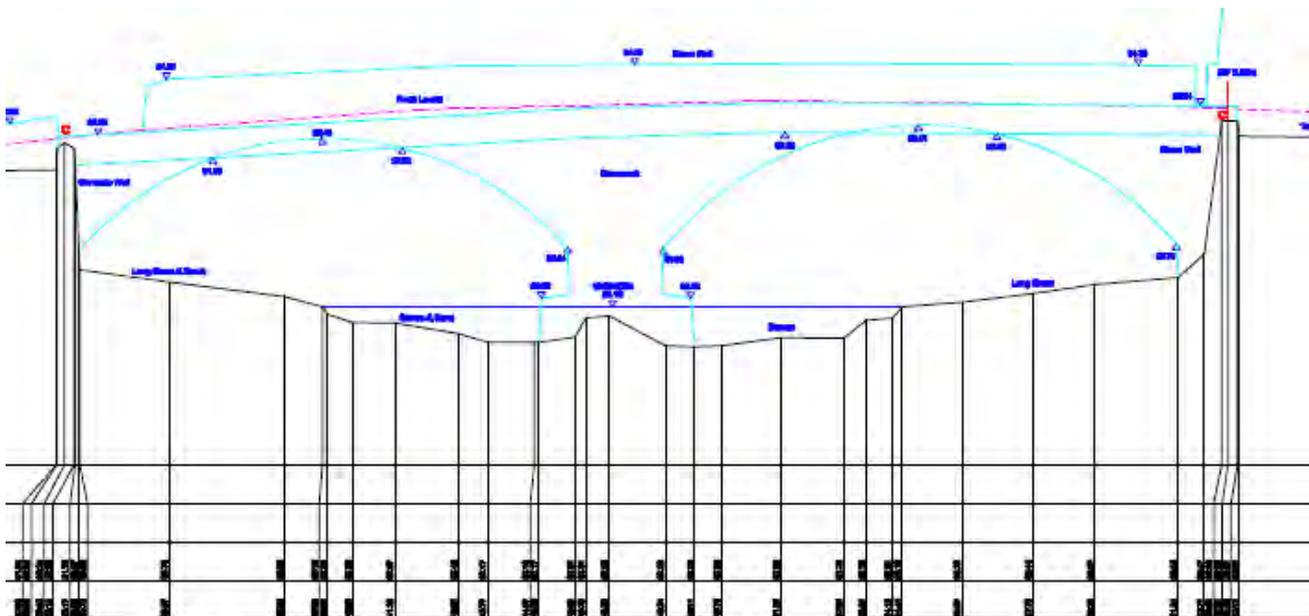
Fig. 3 Cross section of the River Calder at New Rd Bridge from 2009

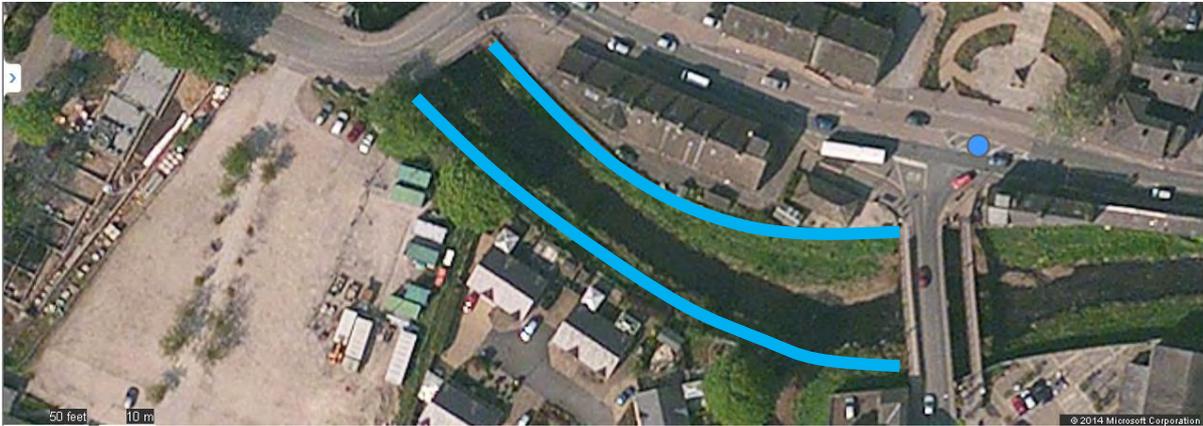
Plate 5. River Calder widening between Caldene and New Rd Bridge.

The locations with the largest shoal accumulations are located in the wider and larger sections of the river where it flows more slowly and deposits materials. The channel sections with shoal accumulations are larger, even with the shoals, than the smaller and narrower sections which have no accumulations. The removal of shoals from the wider sections would not therefore lead to an increase in channel capacity.

The variation in channel size can be seen in plates 5 and 6 as well as in the appendices to this document.

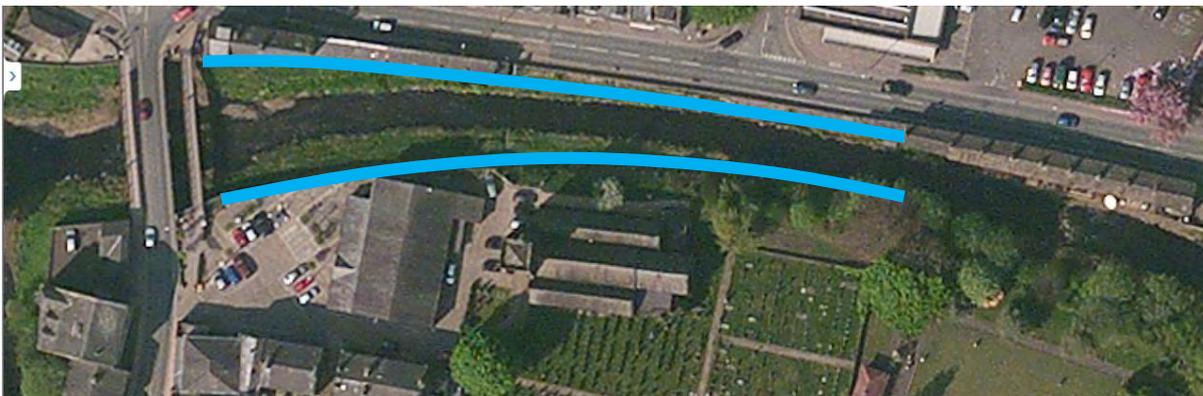
Plate 6. River Calder narrowing downstream of New Rd Bridge.
